# MASS WASTING

## in coastal Alaska

Douglas N. Swanston

U S D A FOREST SERVICE RESEARCH PAPER PNW-83  
1969

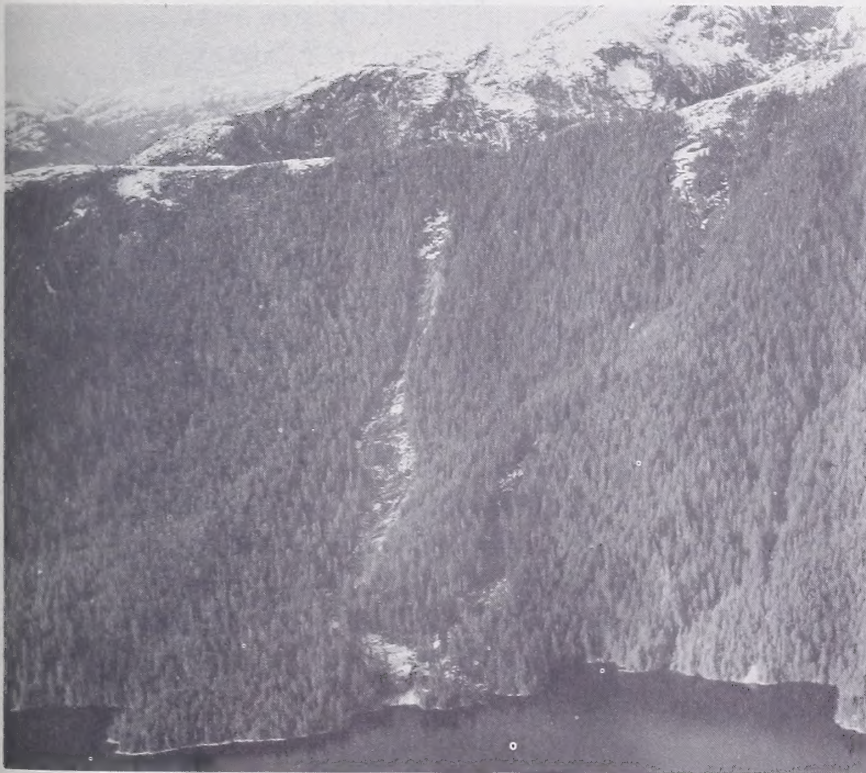
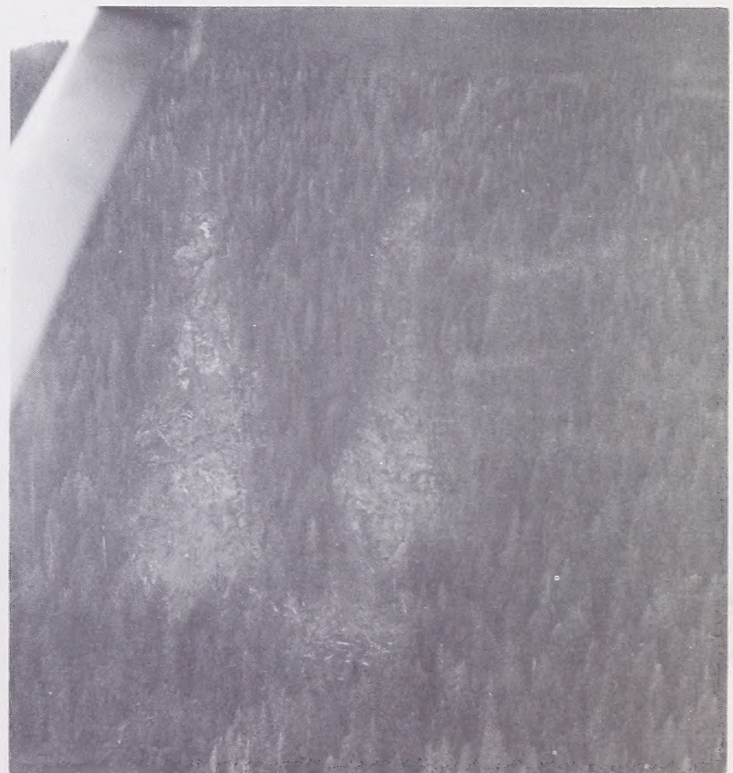
Figure 1.—Aerial views of recent debris avalanche-debris flow combinations on oversteepened slopes of southeast Alaska. A, Slide near Walker Cove, Behm Canal. A debris avalanche was apparently initiated by a rockfall from bluff directly above head of slide trace. Resultant debris flow lower on the slope carried debris directly to the sea. B, Two recent slides near Mirror Lake, Thorne Arm. In this case, much of the debris from the resultant flow has accumulated near the lower end of the slide trace.

The most recent debris avalanches and debris flows are clearly identified by bare linear strips on valley sideslopes and in deep V-notch channels where soil and vegetation have been removed (fig. 1). Increasingly older avalanche and flow scars are identified successively by strips of pioneering species such as willow (*Salix* spp.) and alder (*Alnus* spp.) and finally by even-age stands of Sitka spruce (*Picea sitchensis* (Bong.) Carr.) which are younger than the surrounding timber (figs. 2 and 3). Such

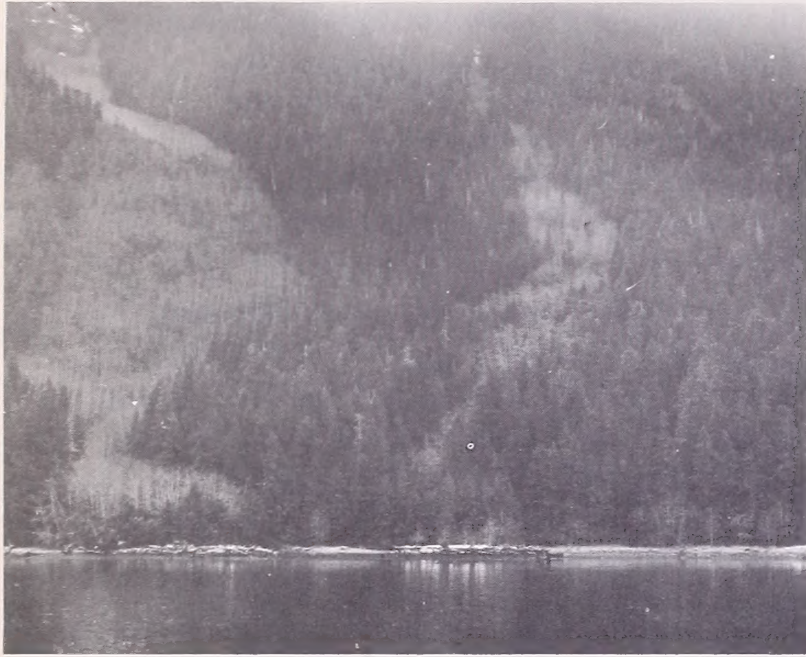
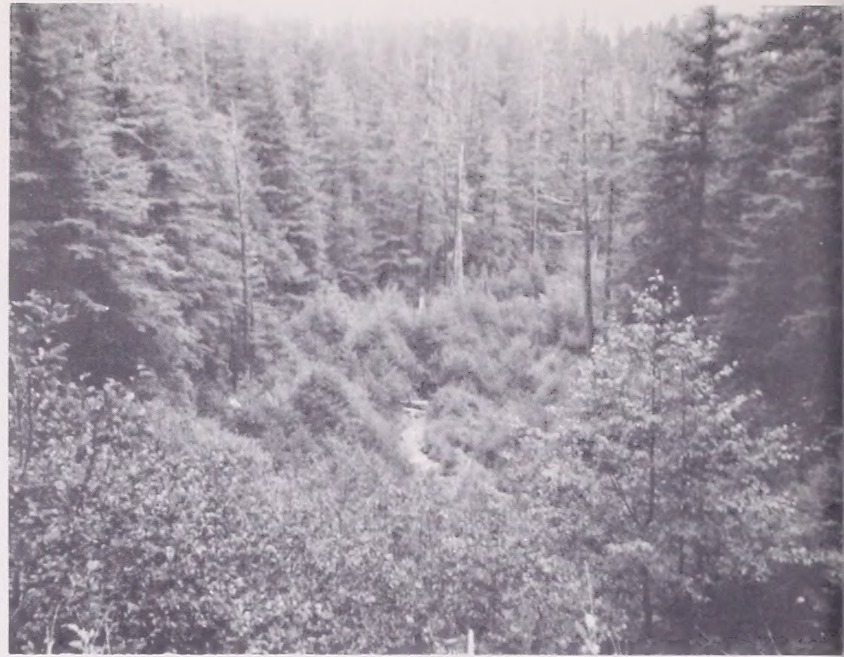
Figure 2.—Older debris avalanche-debris flow traces showing successional regrowth of willow, alder, and Sitka spruce. A, Aerial view of two slide traces revegetated by alder near the head of Walter Island Arm, Port Houghton. B, View of lower slide trace on the south side of Blake Channel Narrows. Note successional regrowth starting with willow and alder in the foreground with spruce moving in behind.

successional regrowth on the older slide traces is easily recognized on aerial photos and provides a convenient means of estimating present stability and past sliding history of a slope. Snow avalanches which produce similar linear tracks on timbered slopes can be differentiated and eliminated from these estimates by observation of the following characteristics. If the track origin lies below the upper timbered boundary, it is probably a debris avalanche track. If the track extends above the timber boundary, it probably originated as a snow avalanche. Also, a snow avalanche produces little soil deposition at the slope base, and there is little or no soil removal in the slide track.

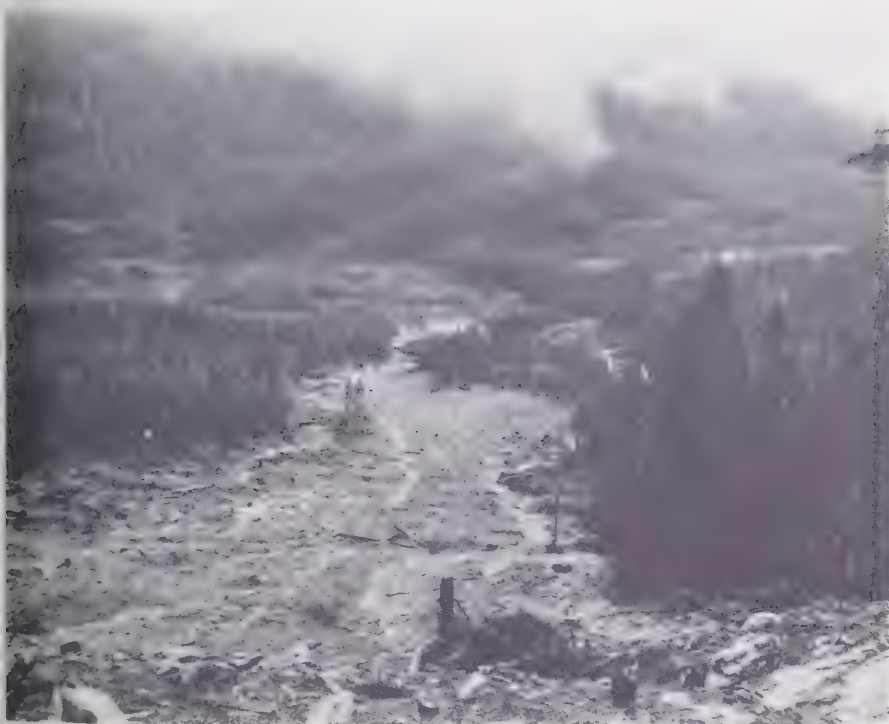
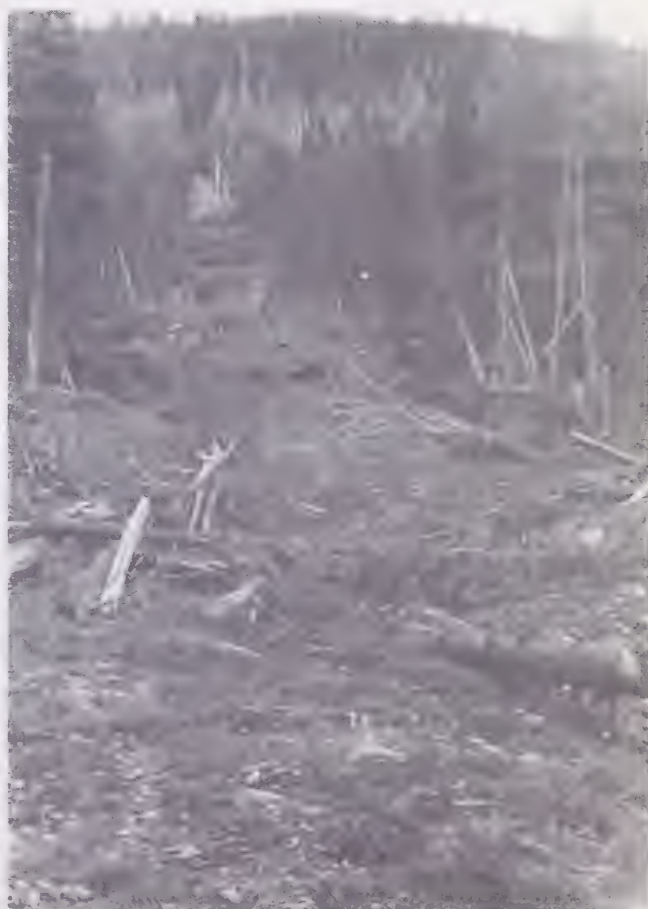
Figure 5.—Combination debris avalanche-debris flows developed in bedrock-derived soil (Tolstoi). A, Martin Creek valley, Bradfield Canal. View toward valley floor from center of slide trace, showing extensive debris flow deposit at base of slope which has broken through the trees at several points to deposit broken timber and other debris in small muskegs beyond. Note shallowness of soil typical of this type of landslide. Glacially rounded dioritic bedrock is exposed by complete removal of the soil layer in the slide trace. B, Maybeso Creek valley. Slide initiated by rockfall from bluff above slide head.

These debris avalanches and debris flows begin characteristically on open slopes, frequently related to local drainage concentrations, and generally clear the slide trace of soil and vegetation to bedrock for the entire length of the slope (fig. 5). The movement is translational, beginning with failure of a small mass of soil along an impermeable bedrock surface

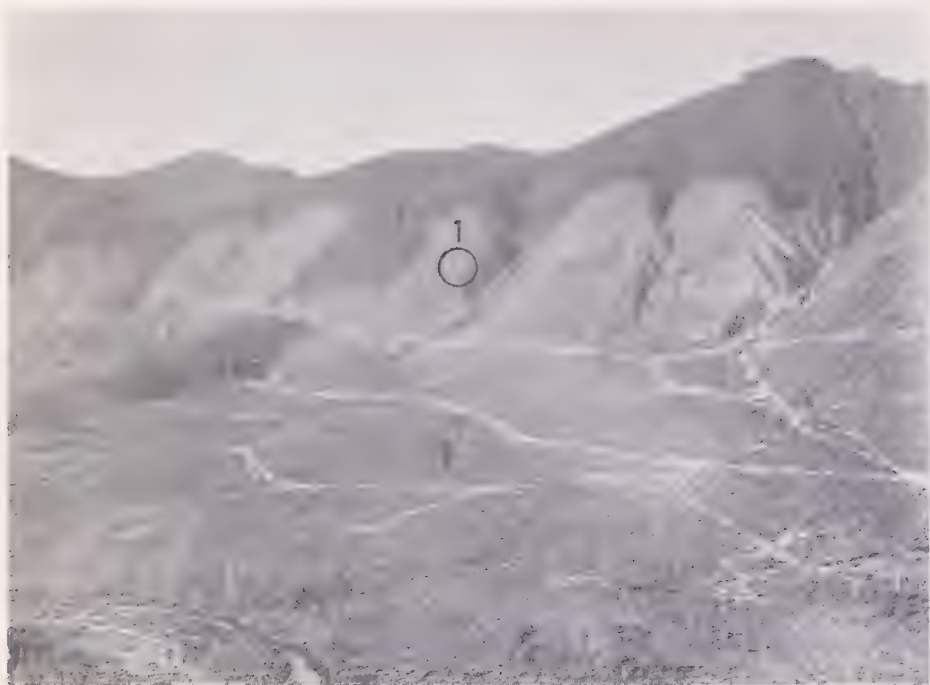
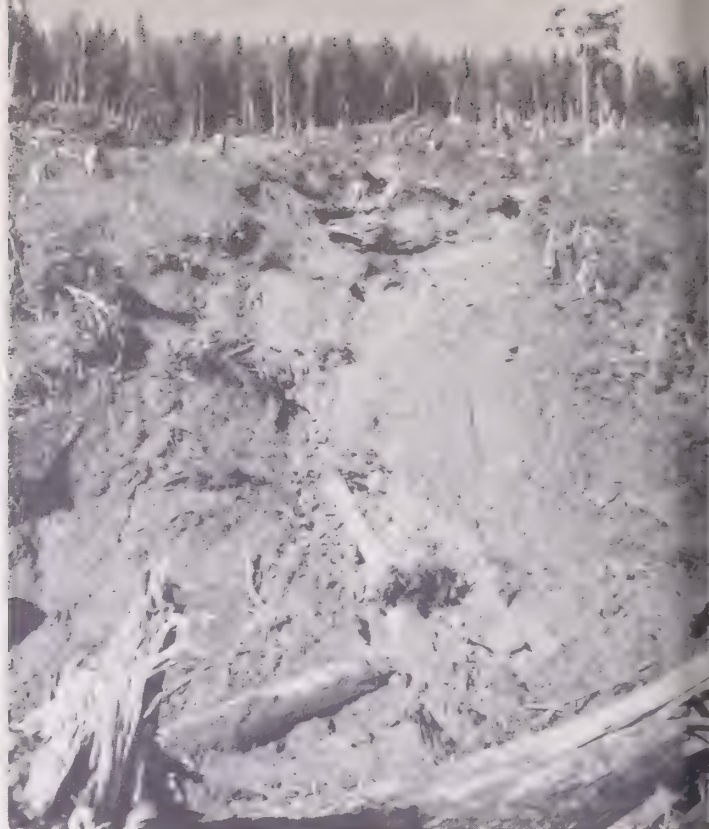
Figure 7.—Combination debris avalanche-debris flows in a glacial till soil (Karta), Maybeso Creek valley, Prince of Wales Island. A, Aerial view of dissected till-covered slope where active sliding is occurring. Recent sliding, directly correlated with a period of high rainfall and resultant concentration of soil water, has occurred to the right of the leave strip in the center of the photo (1). These are probably associated with clearcutting, but there is also much evidence of prelogging slide occurrence. B, Closeup view of slide at site 1. Note the shallowness of the slide trace. The unweathered till which served as the sliding surface is exposed in center foreground as a lighter soil zone next to the long-butted stump. The weathered till or Karta soil is the darker material above it.

Debris avalanches and debris flows in glacial till soils on valley sideslopes frequently begin within linear seepage depressions that dissect the till deposits (fig. 7). These depressions were originally formed as consequent drainage channels<sup>7/</sup> by surface runoff after retreat of glacier ice from the valleys. Since glacier retreat, a shallow podzol soil has developed in the channels and on the surrounding till slopes. At present, the soil in the depressions serves as a center of concentration for soil-water seepage. Surface runoff occurs in the depressions only during periods of extremely high rainfall when the till soil becomes saturated. The occurrence of buried soils, overturned profiles, and buried organic lenses in the lower end of these depressions indicates a past history of active sliding and suggests that, at present, the depressions enlarge themselves chiefly in this manner.

The debris avalanches begin in shallow soils developed in colluvium or glacial till. The slope gradients involved are far greater than the angle of internal friction of the particular soil, greatly intensifying any factors tending to reduce stability. The slopes are extremely unstable and on the verge of failure at all times. Downslope stress on the soil is increased due to the weight of added water during periods of high rainfall. Increased pore-water pressure or destruction of stabilizing root systems aggravates the condition and may initiate sliding, as may bank undercutting near a stream. Usually these slides have short runs, beginning at the tops of valley sideslopes and ending at the streams (figs. 7 and 8).

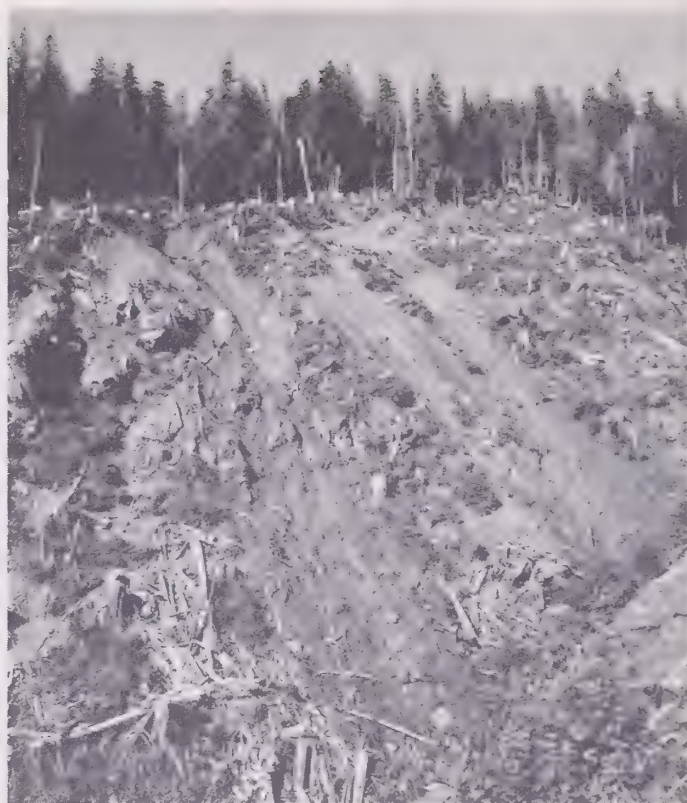
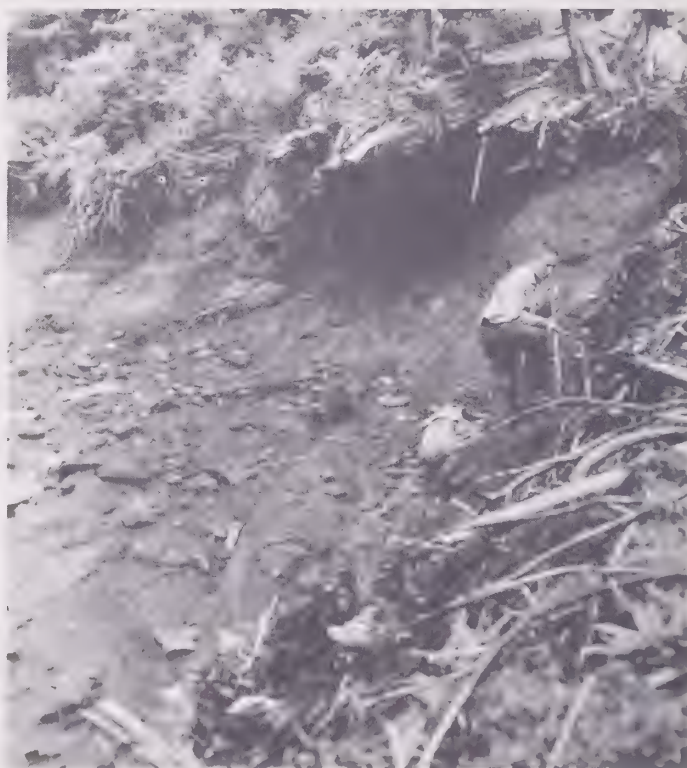
Figure 8.—Debris avalanches in steep-walled V-notch drainages. A, In till soil, Maybeso Creek valley. B, In bedrock-derived soil, Neets Bay. Note the masses of small roots overhanging the headwall of the slide. Many still remain firmly attached to the fractured and jointed bedrock substrata.

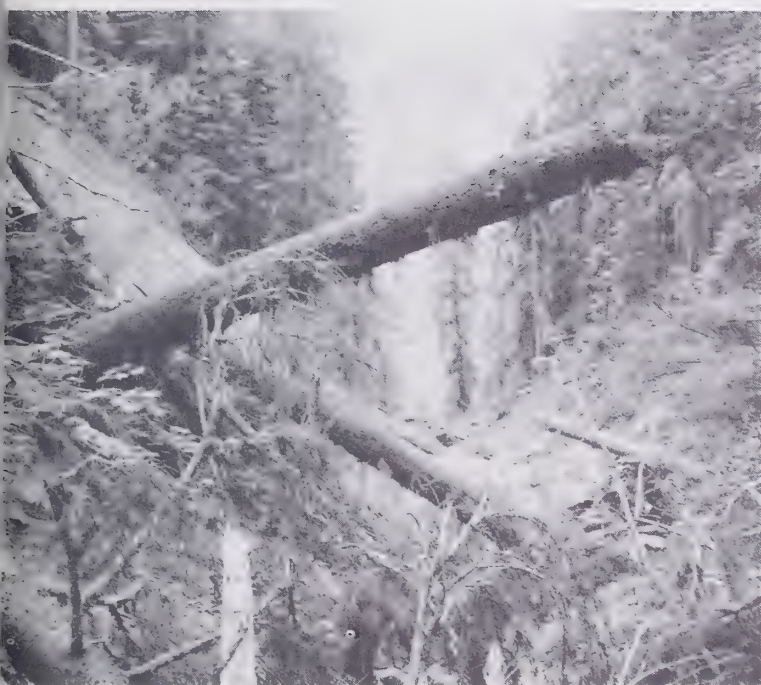
Figure 9.—Natural dam across V-notch drainage produced by accumulation of forest debris. Upstream debris-avalanching produces a buildup of soil and organic debris behind the dam which, when released, produces a large-scale debris torrent.

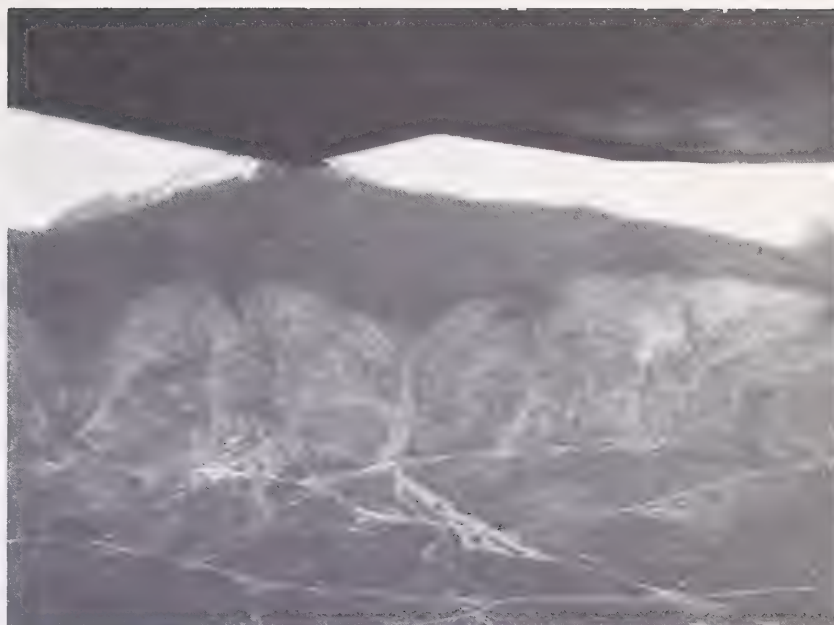
Figure 10.—Torrent flow deposit (center foreground) produced by failure of debris dam within the timber in center V-notch.

If the amounts of material are sufficient, they may become debris flows upon reaching the streams as a result of increased water content. More frequently, the debris is simply carried away as increased sediment load in the stream. Rapp (1961) in Scandinavia and Bishop and Stevens (1964) in southeast Alaska describe a phenomenon associated with this kind of flow resulting from debris avalanche accumulations in the bottoms of steep-sided channels. Debris forms a dam across a stream at the base of an avalanche. Subsequent material from upstream avalanches accumulates behind this barricade (fig. 9). When the dam gives way, a large volume debris flow or debris torrent occurs (fig. 10).
